EMISSIONS FROM AN OVERHEATED ELECTRIC MOTOR WITH SLOT  
CELLS AND WINDING PHASES INSULATED WITH AN AROMATIC  
POLYAMIDE PAPER

Peter Demas, et al

Naval Ship Research and Development Center  
Bethesda, Maryland

April 1975

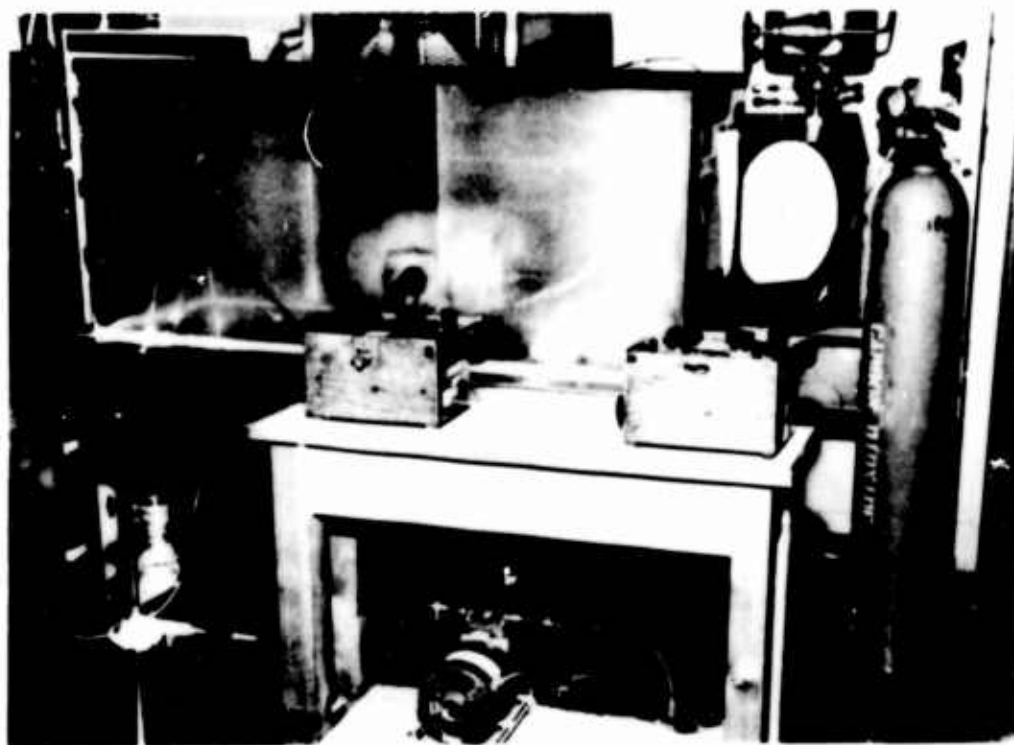
Figure 2  
Electric Motor Outgassing  
and Collection Assembly

During the next run, motor temperature  $334^{\circ}\text{C}$  ( $631^{\circ}\text{F}$ ), more oil ran off the motor, and the condensation on the tank walls was greater. Figure 2 is a photograph of the complete assembly and shows the degree of condensation on the glass walls at the end of the run. When, upon completion of each of the runs, the motor was turned off and the tank cooled, the condensation on the glass walls of the tank (as well as the oil on the steel bench top) acquired a semisolid crystalline appearance.

An all glass cover (aquarium type tank 48 inches long, 18 inches wide, 22 inches high)\* was placed over the motor. The rim of the glass tank was sealed to the stainless steel bench top with silastic which was allowed to dry (75 hours). The assembly was then leak tested. The complete assembly is shown in the drawing of figure 1 and photograph of figure 2.
